## Device limitations for STM8AF62xx automotive MCUs featuring up to 32 Kbytes of Flash program memory

### Silicon identification

This errata sheet applies to the STMicroelectronics STM8AF624x and STM8AF626x devices. The full list of root part numbers is given in [Table 2](#).

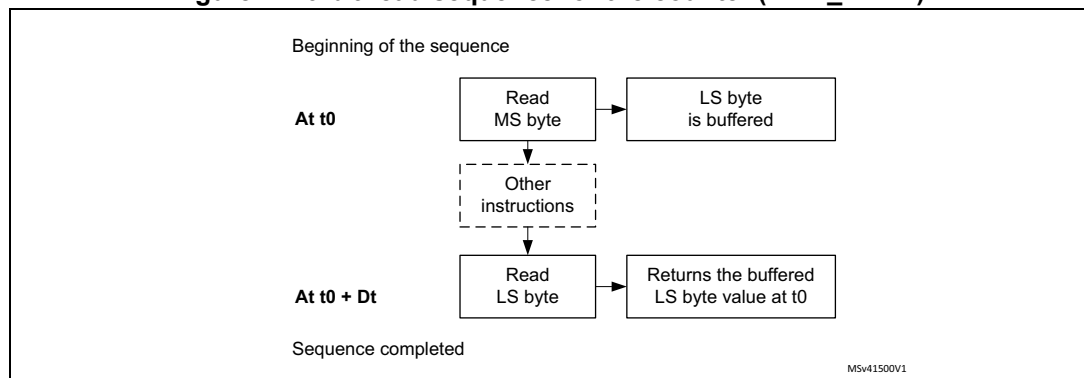
**Figure 1. 16-bit read sequence for the counter (TIMx\_CNTR)**

An 8-bit buffer is implemented for reading the 16-bit counter registers. Software must read the MS byte first, after which the LS byte value is buffered automatically (see [Figure 1](#)). This buffered value remains unchanged until the 16-bit read sequence is completed.

When any multi-cycle instruction precedes the read of the LSB, the content of the buffer is lost and the second read returns the immediate content of the counter directly.

Do not use multi-cycle instructions before reading the LSB.
