PIC24FJ256GA110 Family Silicon Errata and Data Sheet Clarification

The PIC24FJ256GA110 family devices that you have received conform functionally to the current Device Data Sheet (DS39905E), except for the anomalies described in this document.

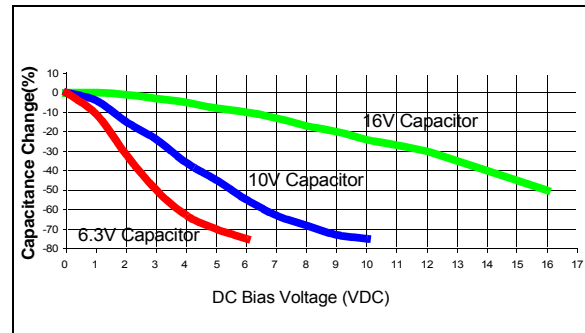
FIGURE 2-4 DC BIAS VOLTAGE vs. CAPACITANCE CHARACTERISTICS

A typical DC bias voltage vs. capacitance graph for 16V, 10V and 6.3V rated capacitors is shown in Figure 2-4.

When selecting a ceramic capacitor to be used with the internal voltage regulator, it is suggested to select a high-voltage rating, so that the operating voltage is a small percentage of the maximum rated capacitor voltage. For example, choose a ceramic capacitor rated at 16V for the 2.5V core voltage. Suggested capacitors are shown in Table 2-1.
