PIC18F47J13 Family Silicon Errata and Data Sheet Clarification

The PIC18F47J13 family devices that you have received conform functionally to the current Device Data Sheet (DS39974A), except for the anomalies described in this document.

PIC18F47J13 FAMILY

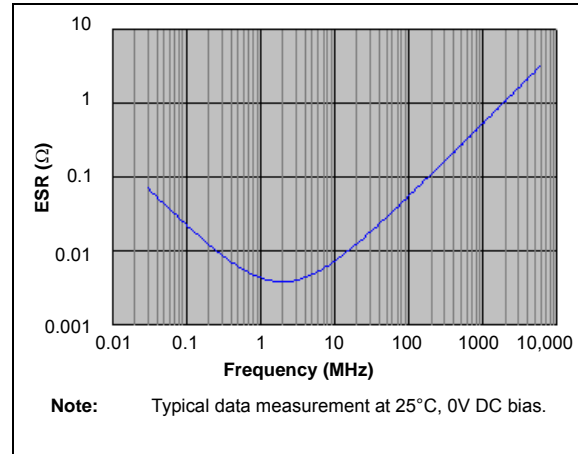
FIGURE 2-3 FREQUENCY vs. ESR PERFORMANCE FOR SUGGESTED VCAP

Designers may use [Figure 2-3](#) to evaluate ESR equivalence of candidate devices.

On “F” devices, a low-ESR ($< 5\Omega$) capacitor is required on the VCAP/VDDCORE pin to stabilize the voltage regulator output voltage. The VCAP/VDDCORE pin must not be connected to VDD and must use a capacitor of 10 μF connected to ground. The type can be ceramic or tantalum. Suitable examples of capacitors are shown in [Table 2-1](#). Capacitors with equivalent specifications can be used.

It is recommended that the trace length not exceed 0.25 inch (6 mm). Refer to [Section 30.0 “Electrical Characteristics”](#) for additional information.

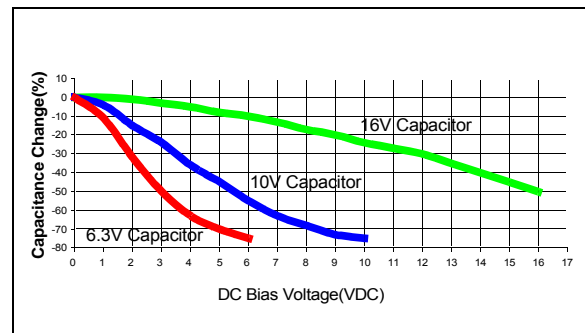
FIGURE 2-4 DC BIAS VOLTAGE vs. CAPACITANCE CHARACTERISTICS

A typical DC bias voltage vs. capacitance graph for 16V, 10V and 6.3V rated capacitors is shown in Figure 2-4.

In addition to temperature tolerance, the effective capacitance of large value ceramic capacitors can vary substantially, based on the amount of DC voltage applied to the capacitor. This effect can be very significant, but is often overlooked or is not always documented.

When selecting a ceramic capacitor to be used with the internal voltage regulator, it is suggested to select a high-voltage rating, so that the operating voltage is a small percentage of the maximum rated capacitor voltage. For example, choose a ceramic capacitor rated at 16V for the 2.5V core voltage. Suggested capacitors are shown in Table 2-1.
